MEATH COUNTY COUNCIL

DECLARATION

PLANNING REFERENCE NUMBER: TA/S52461

BUILDING SURVEY REPORT

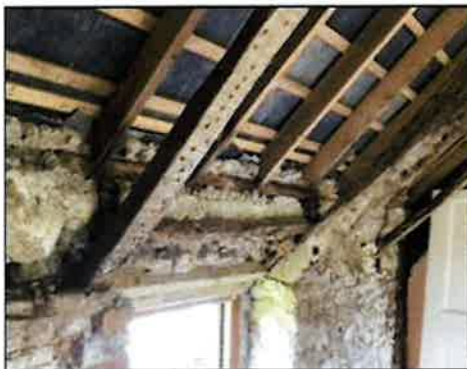
Photo - 44 Note - rotten roof timbers and window heads throughout.

- Removal of the existing roof covering.
 - Replacement of all structural timber with C24 grade rafters and ties.
 - Installation of a 160gsm roofing membrane.
 - Application of treated laths and new natural slates.
 - Installation of angle clay ridge tiles and slate trim.
-

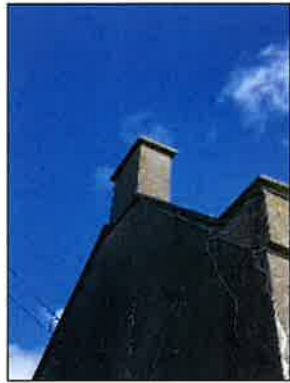
Photo - 1

G2 Roof coverings

The main roof on the dwelling house consists of a pitched, with one hip, with cement fibre slate finish. The slates are in poor condition which require replacing.

I recommend obtaining a competent Roofer to inspect further and carry out the necessary repairs based on this investigation.

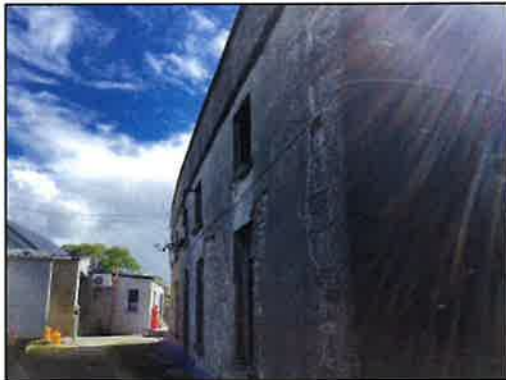
Valley: There is a valley system which has deteriorated over the years and has let in water into the Roof and wall structure.

This has therefore caused significant structural damage which in-turn has rendered the dwelling house Structurally unsound and Dangerous.

Photo - 11 Note - structural bulge to front wall due to deteriorated roof valley.

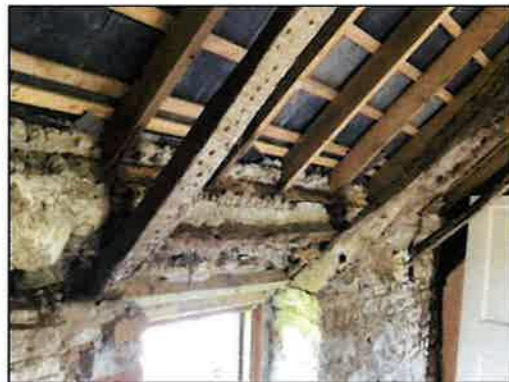
I recommend removing the roof due to the following structural reasons;
No felt or breathable membrane fitted.

Rotting occurring along the valley boards due to water ingress.

There are old roof beams which date back to the original build in which I recommend protecting by constructing enabling and temporary works as currently structurally unsound and dangerous.

Photo - 44 Note - rotten roof timbers and window heads throughout.
