MEATH COUNTY COUNCIL

DECLARATION

PLANNING REFERENCE NUMBER: TA/S52461

BUILDING SURVEY REPORT

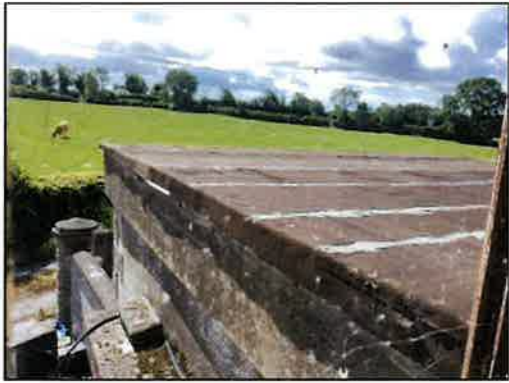
Photo - 6 Flat Roof to rear Kitchen extension requires replacing to a new Warm Roof system

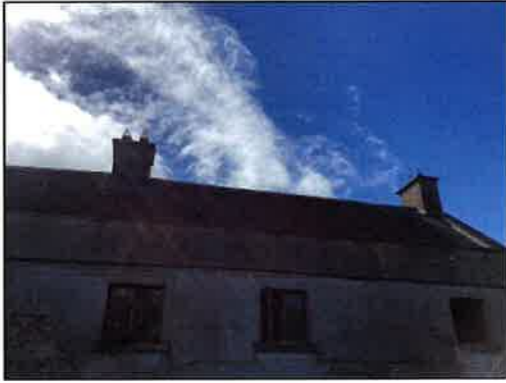
Photo - 7

This is an incorrect plaster mix to apply to a Limestone structure as stonework must be able to breathe and move.

I recommend removing the sand and cement plaster and carry out appropriate structural remediation required to restore the stonework.

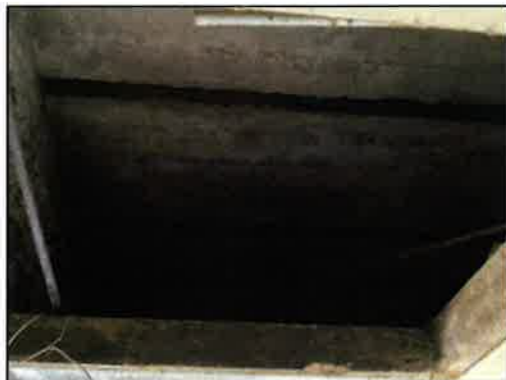
Photo - 52 In-situ concrete slab over Kitchen extension over disused railway lines

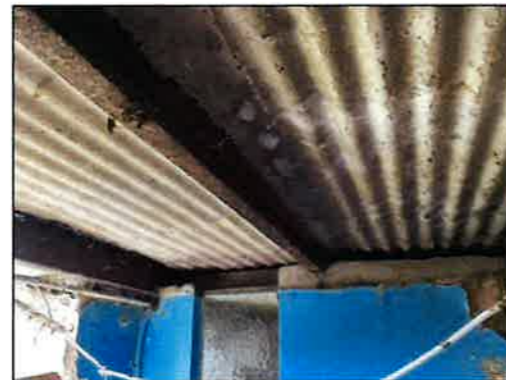
Photo - 53 Incorrect reinforced concrete detail therefore must be removed as structurally unsound and dangerous.

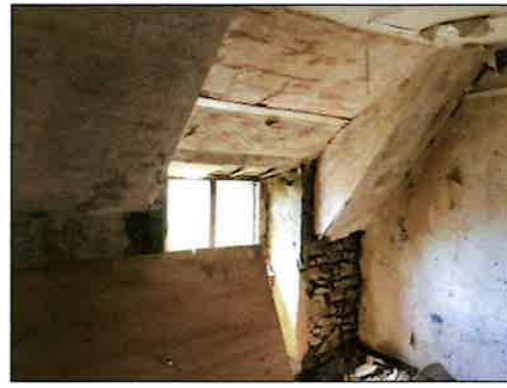
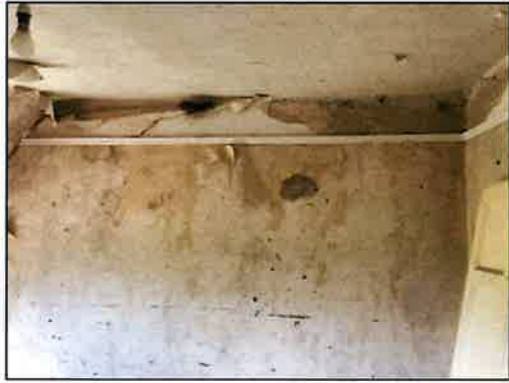
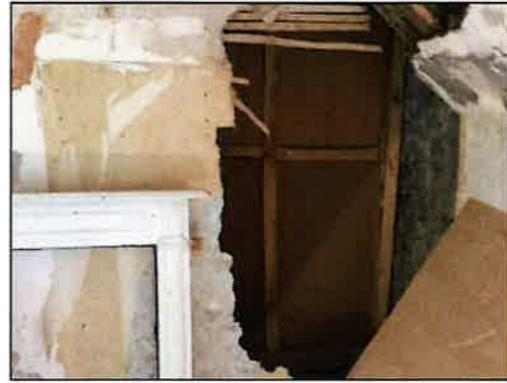
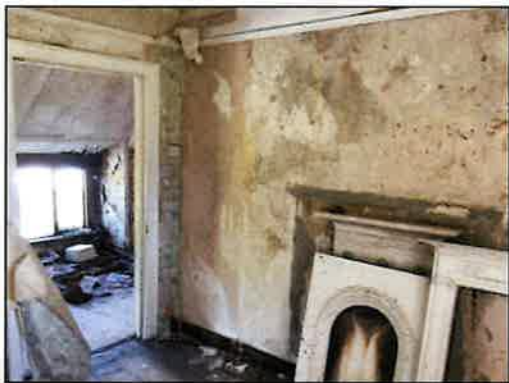
The ground floor is constructed of concrete slab, which is in poor condition with structural cracking and sinking occurring.

The upper floors are constructed of suspended timber system which is currently rotten and requires removing as structurally unsound and dangerous.

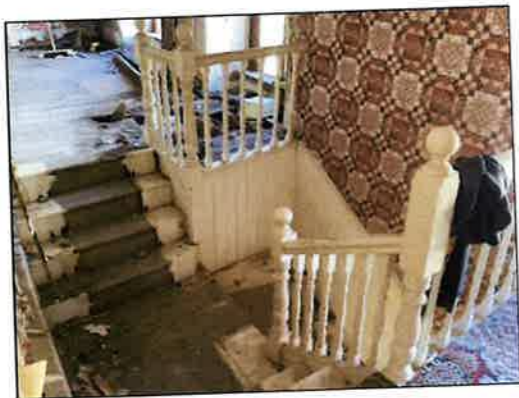
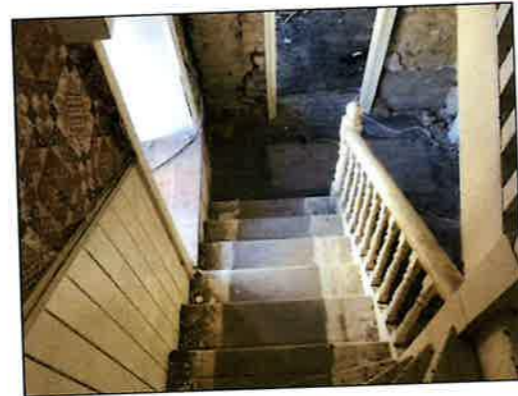
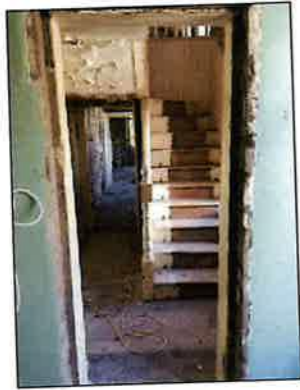
The Kitchen units are in poor condition throughout. Therefore it is more cost effective to replace these built in units.

Internal joinery is in poor condition throughout and is more cost effective to replace than to fix.

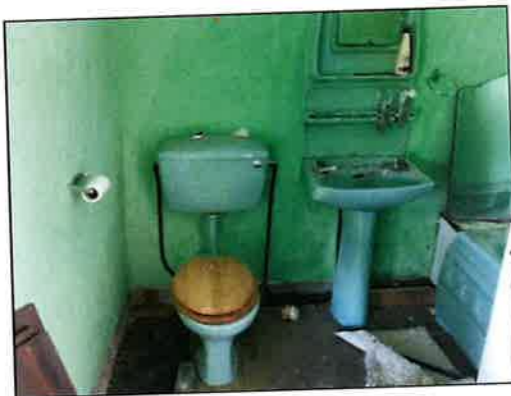
Photo - 87

The current bathroom systems are in poor condition and require replacing throughout.

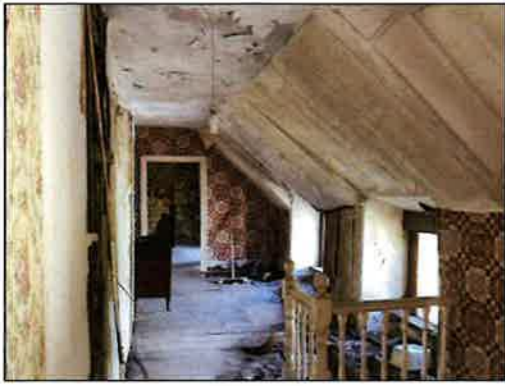
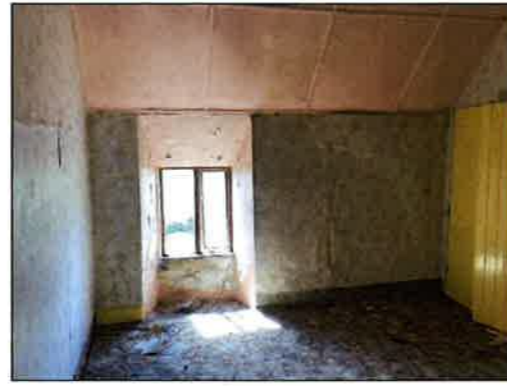
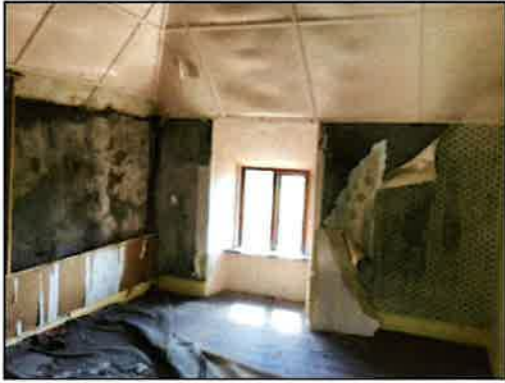
On the day of inspection, we were equipped with a moisture meter which detected high moisture readings throughout. We recommend investigating this further as the building requires professional Damp-Proofing. The damp issues detected must be remediated as this affects the integrity of the structural fabric rendering it dangerous to the occupants.

It appears that passive ventilation is not fitted to all of the bedrooms and therefore requires fitting.

We recommend fitting a mechanical ventilation to the bathrooms.

Two number wall vents must be incorporated into any room with a Gas fireplace, i.e., one at low level and one at high level. The wall vents must be located away from window and door opens on the external wall to reduce the risk of cracking occurring.

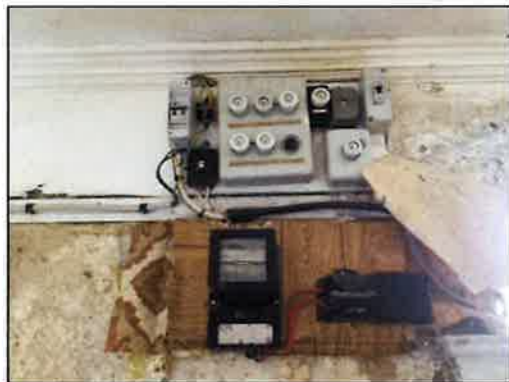
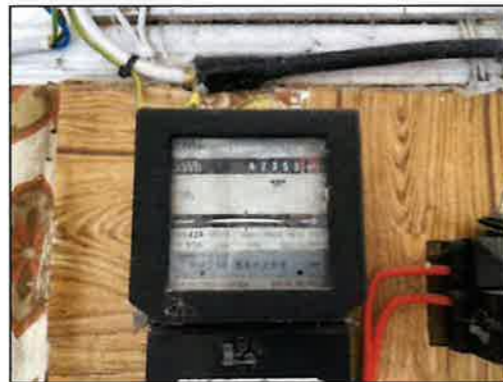
The electricity supply was off when I inspected.

I recommend obtaining a competent Registered Electrician to design, replace and rewire new compliant certified system.

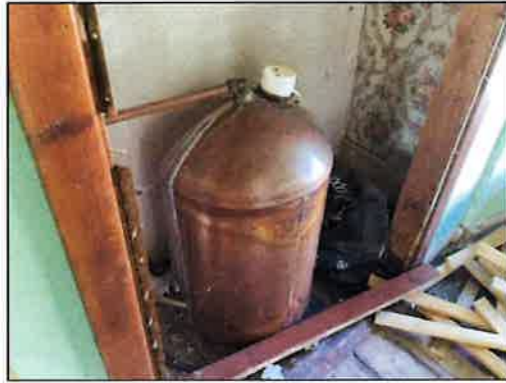
Photo - 93

The hot water is provided by an immersion.

We recommend obtaining a competent Plumbing Contractor to fit a new Heat Pump system, thermostatically controlled and zoned energy efficient system.

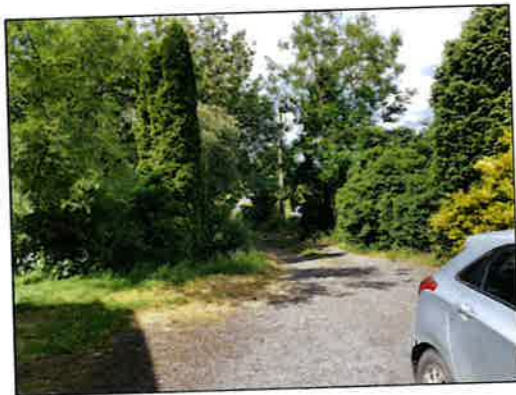
Photo - 94

Condition of Boundaries: Refer to photos below highlighting the current condition and issues detected to the boundaries and grounds.

Vendors solicitor to provide a Land Registry Compliant Map to check that the boundaries on the map correlate with what is on the ground.
